DEPARTMENT OF TRANSPORTATION

Contract #: 04-0120F4Cty: SF/ALA Rte: 80 PM: 13.2/13.9File #: 99.28**WELDING INSPECTION REPORT****Resident Engineer:** Casey, William**Address:** 333 Burma Road**City:** Oakland, CA 94607**Report No:** WIR-029003**Date Inspected:** 07-Jan-2013**Project Name:** SAS Superstructure**OSM Arrival Time:** 600**Prime Contractor:** American Bridge/Fluor Enterprises, a JV**OSM Departure Time:** 1630**Contractor:** American Bridge Manufacturing**Location:** Reedsport, OR**CWI Name:** Harry Woodworth**CWI Present:** Yes No**Inspected CWI report:** Yes No N/A**Rod Oven in Use:** Yes No N/A**Electrode to specification:** Yes No N/A**Weld Procedures Followed:** Yes No N/A**Qualified Welders:** Yes No N/A**Verified Joint Fit-up:** Yes No N/A**Approved Drawings:** Yes No N/A**Approved WPS:** Yes No N/A**Delayed / Cancelled:** Yes No N/A**Bridge No:** 34-0006**Component:** Bike Path Railing Call Box**Summary of Items Observed:**

The QAI witnessed work in progress related to Bike Path Railing Call Box:

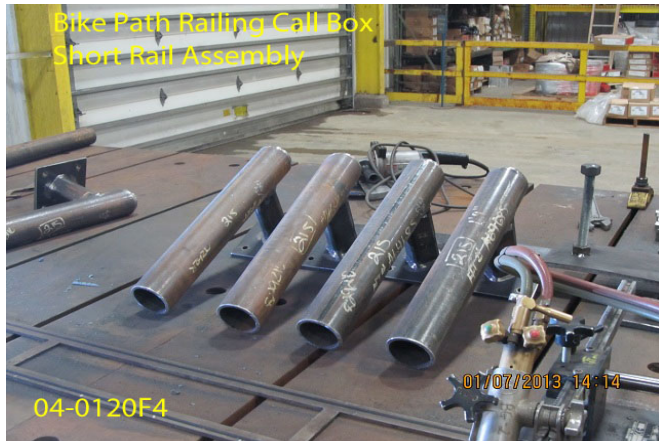
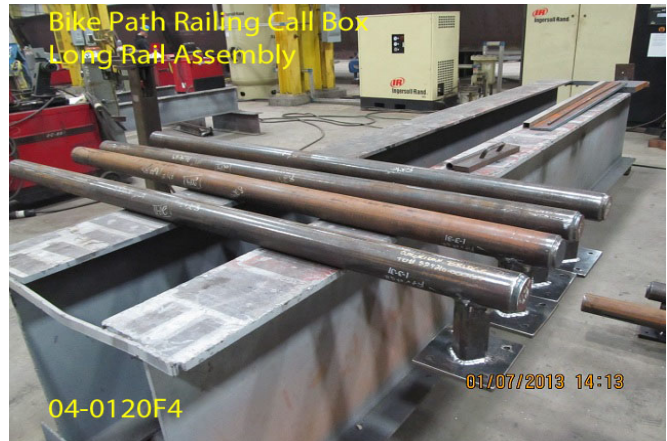
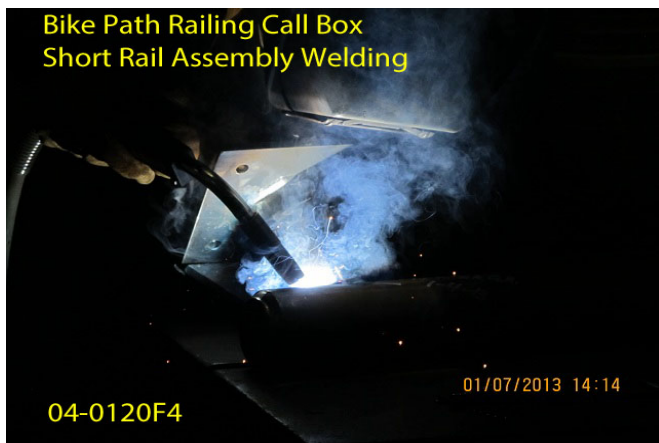
This QAI observed ABM personnel performing fit up and tack welding operations of multiple parts for the Bike Path Railing Call Box. The ABF approved drawing numbers utilized were sheet number 2 of 4. The parts fit on the components were 215 to 216, 214 "Long Pipe Rail" to 217 "End Plate" and 213 to 216 for the rail assembly. The ABM Welder was Ron Bowser (ID# A4) and utilizing ABM FCAW WPS #ABM-SAS-031.

The QAI observed ABM Quality Control Inspector (QCI), Harry Woodworth monitor the fit up and welding operations, checking pre-heat and interpass temperatures, perform dimensional and visual inspection which appeared to be in conformance with the approved drawings noted above, the standard specification and special provisions.
